West Fertilizer Emergency Response

Environmental Protection Agency

West, McLennan County, Texas

Time Line

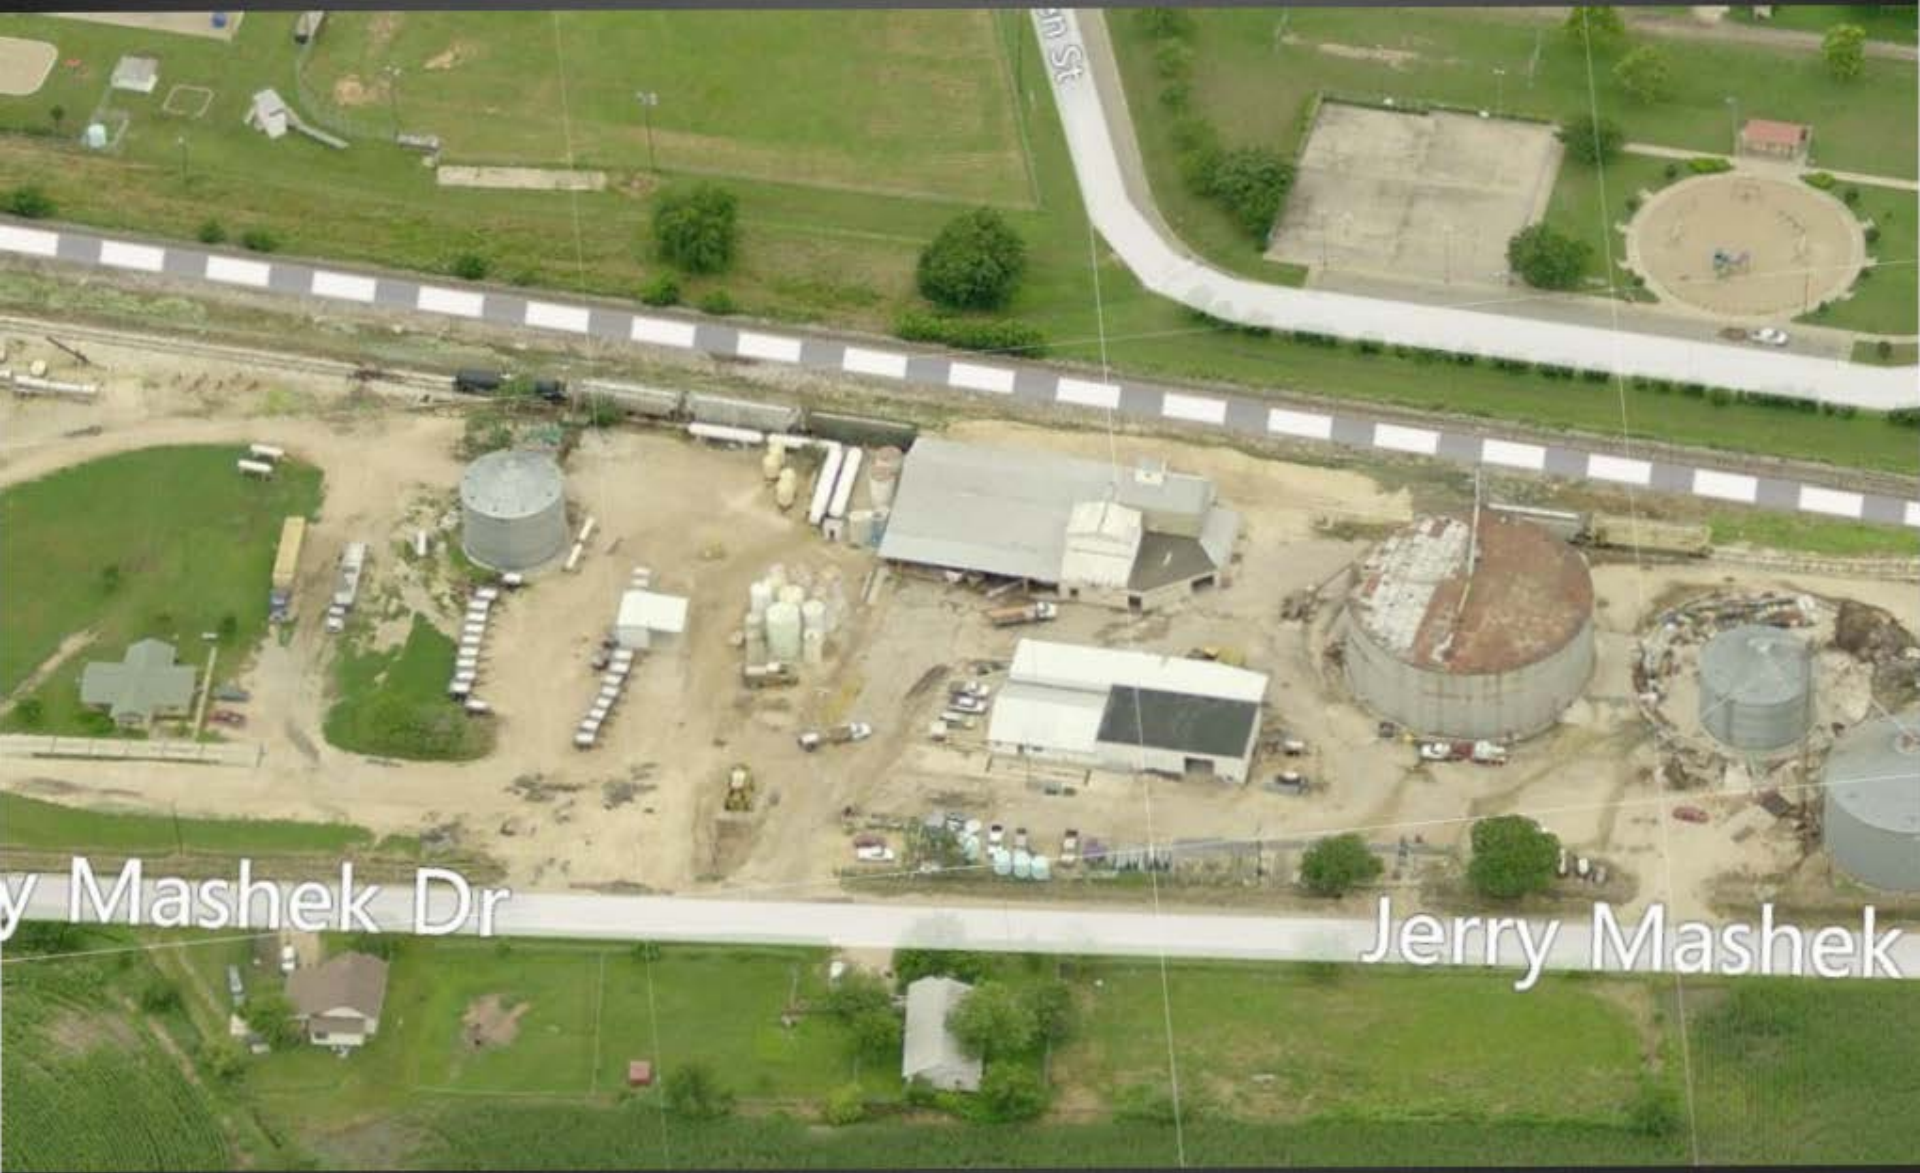
West Fertilizer Plant prior to 4/17/2013

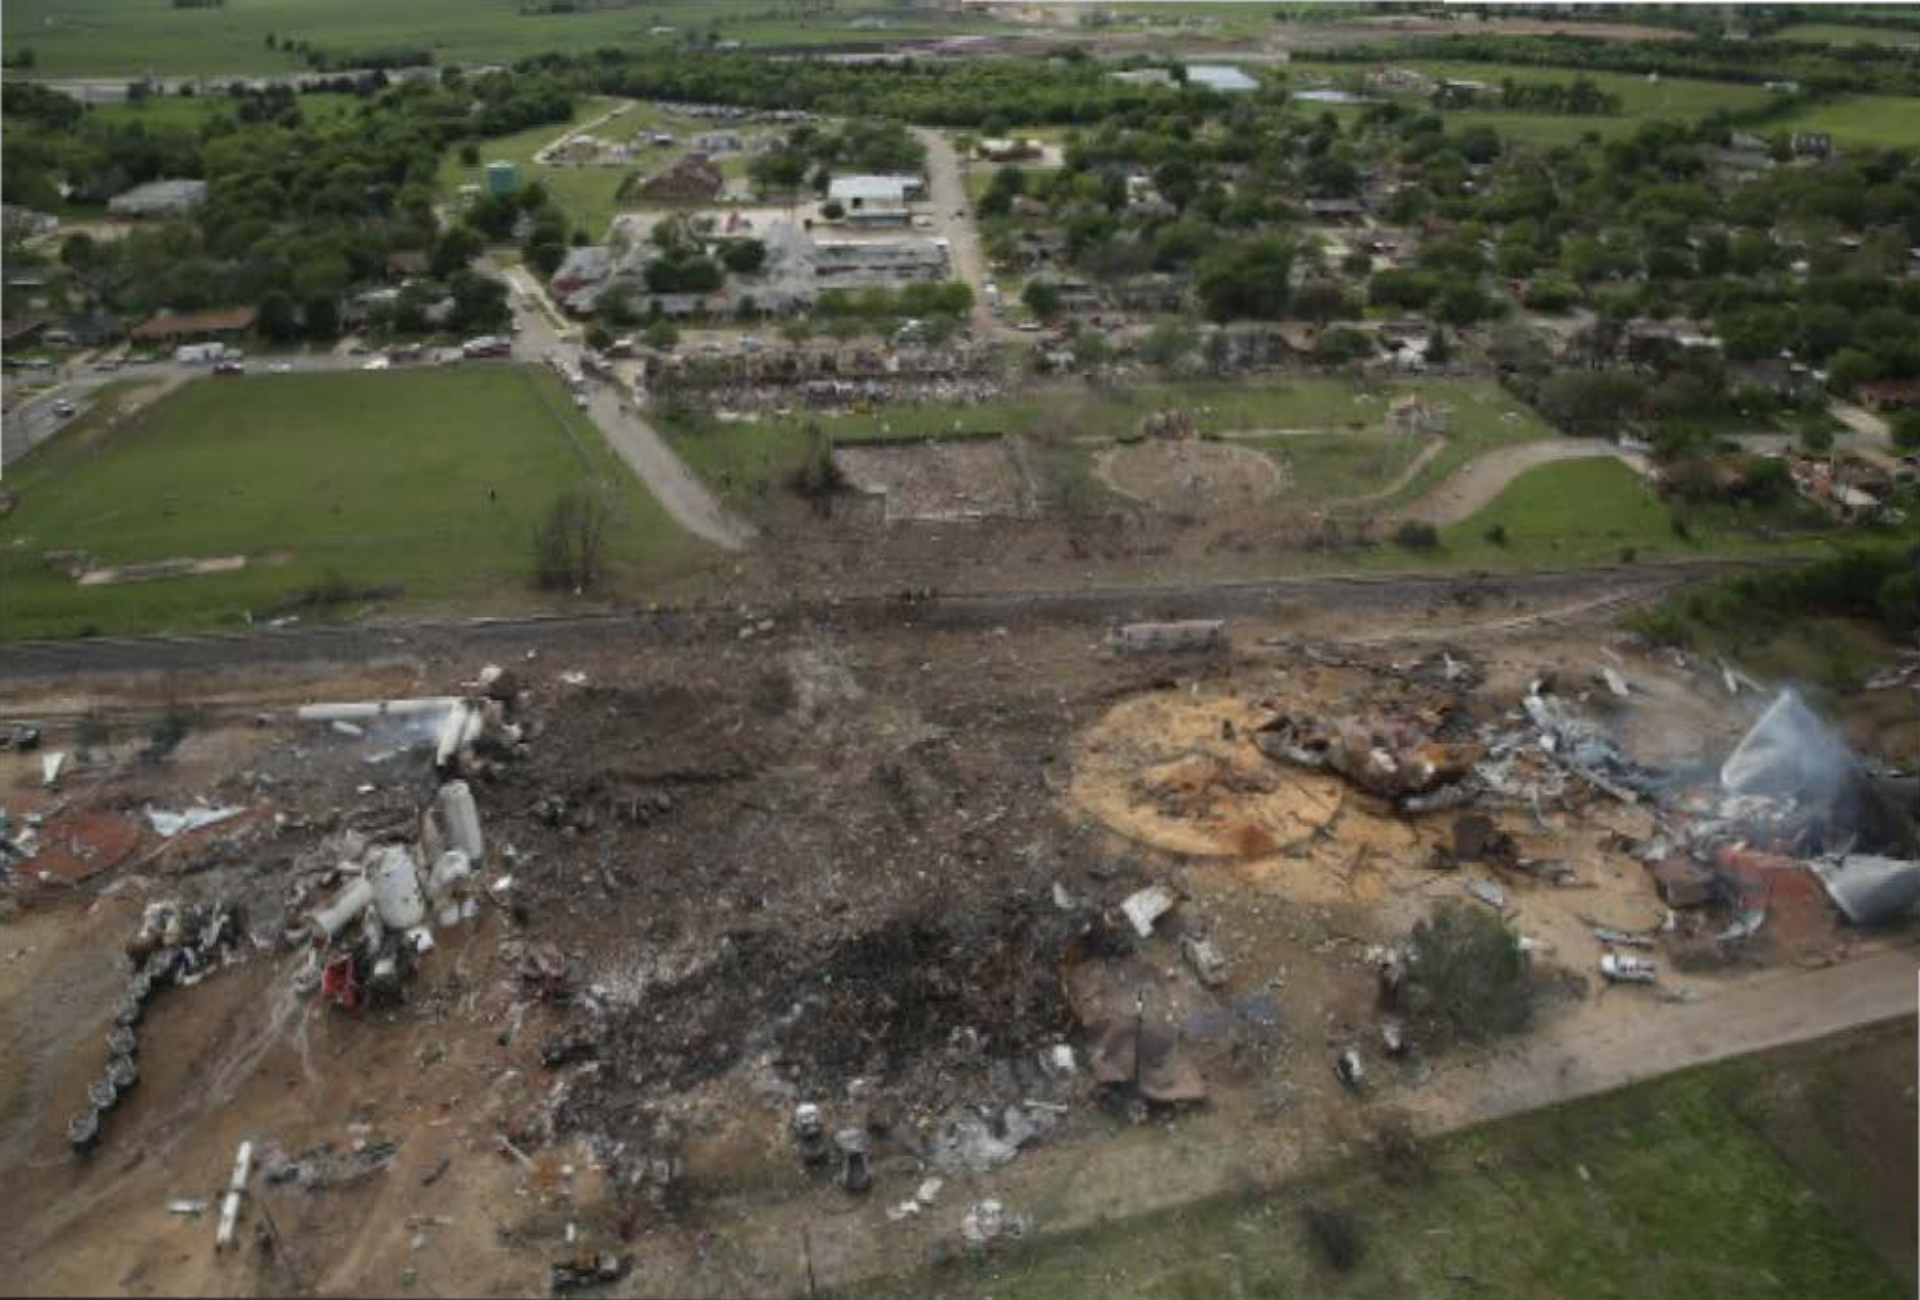
West Fertilizer Plant post 4/17/2013

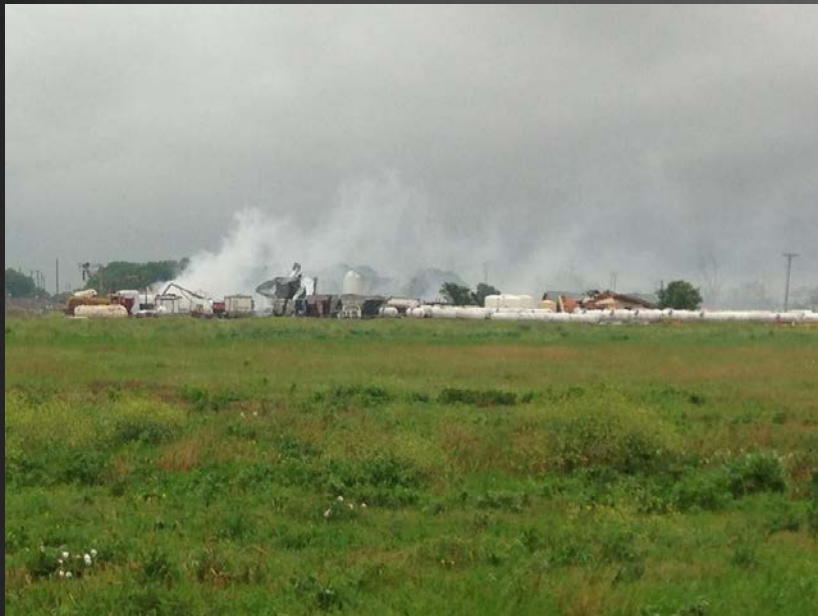
Explosion site smoldering.

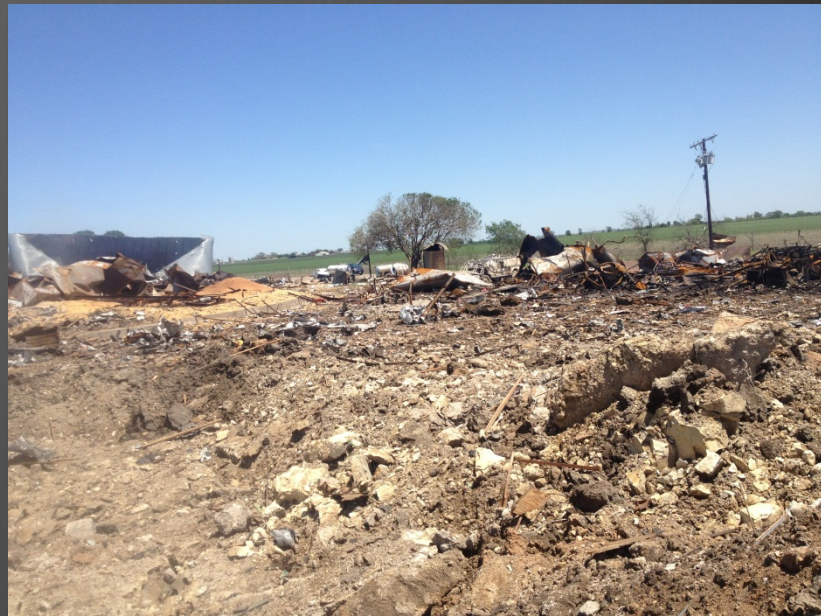
Point of fertilizer detonation

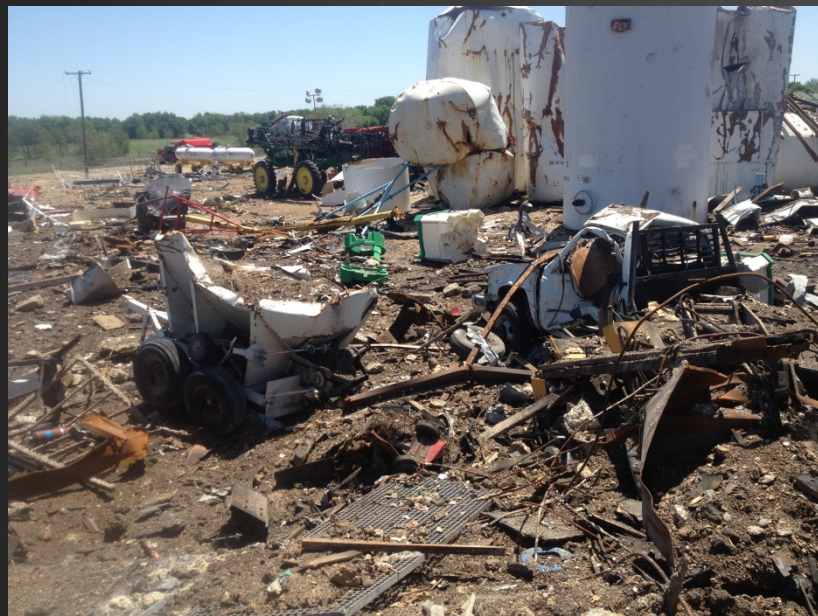
Remaining fertilizer plant infrastructure.

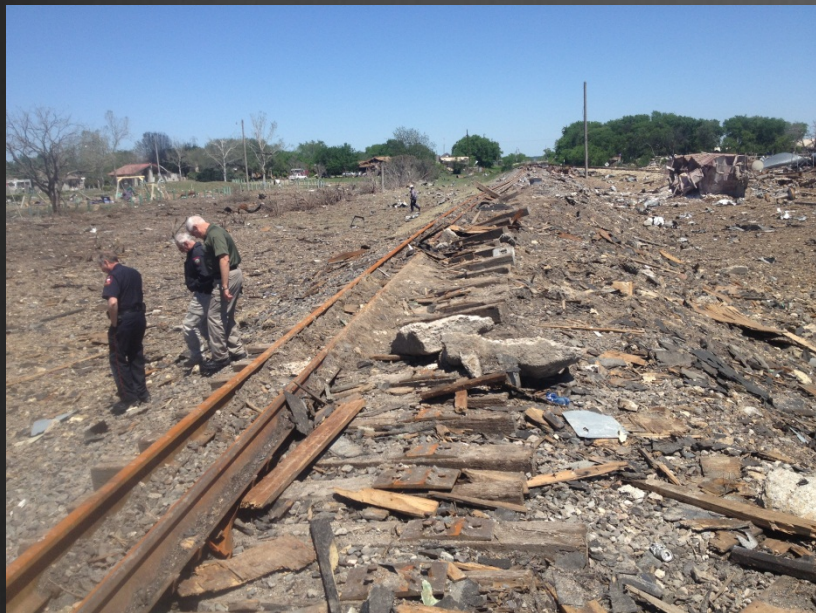
Damage to railroad near explosion site.

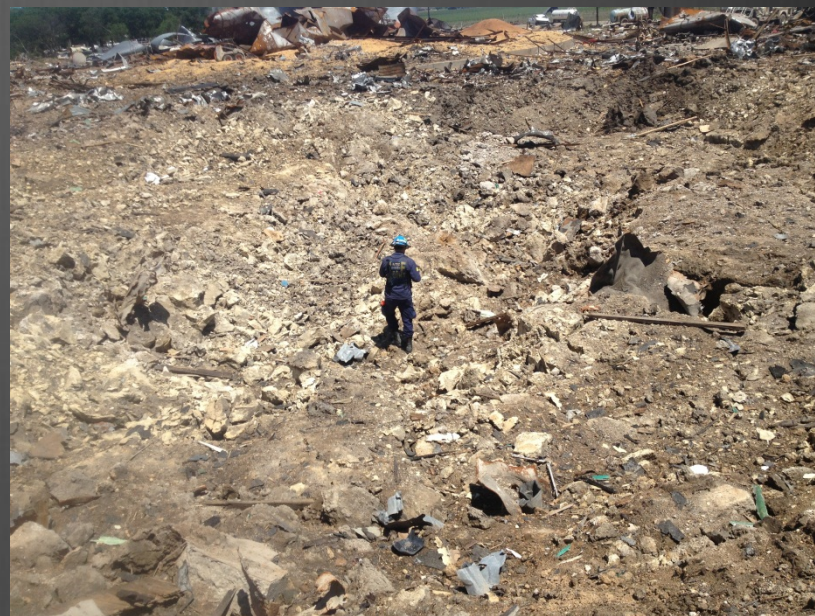
Crater at explosion site.

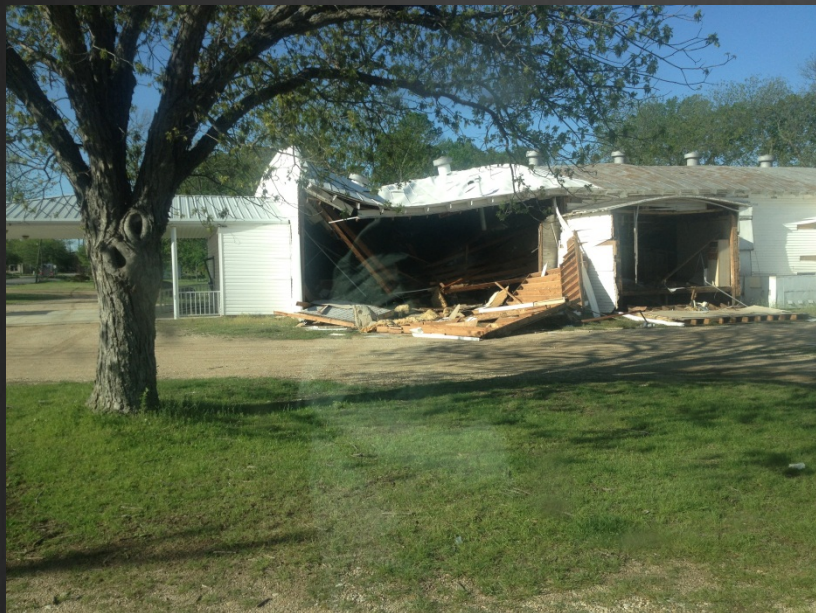
Damage to homes near the explosion site.

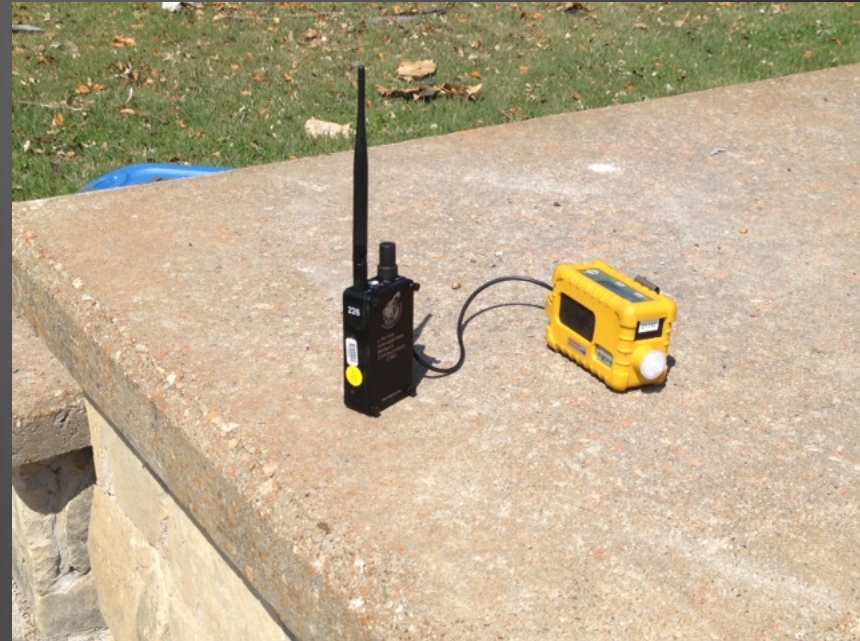
Air monitor with Viper transmitter, located at park adjacent to site.

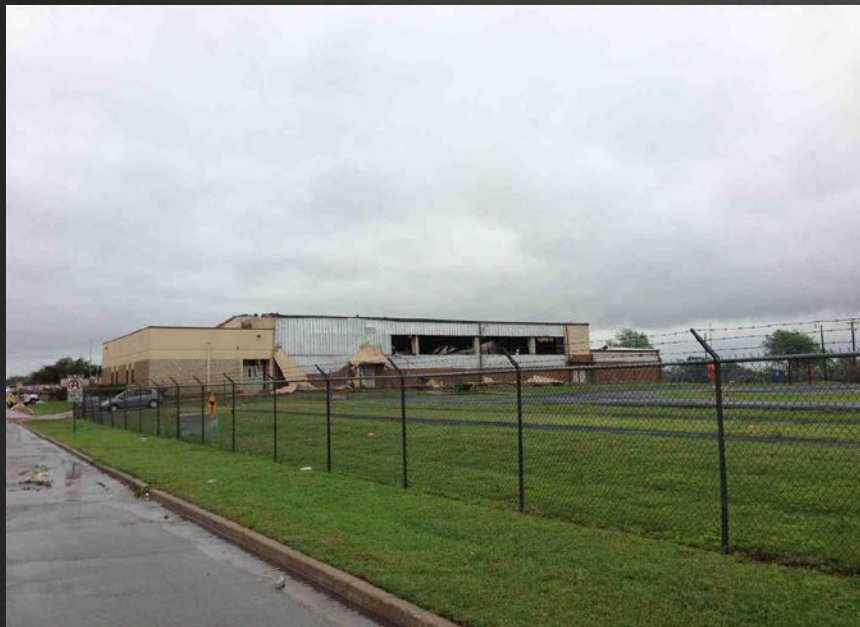
Damage to West Middle School.

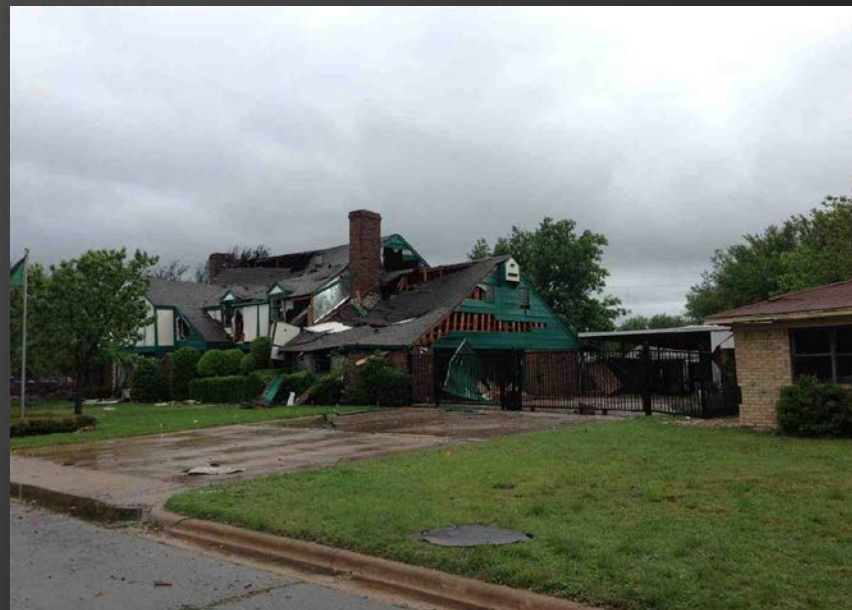
Damage to homes within the surrounding neighborhood.

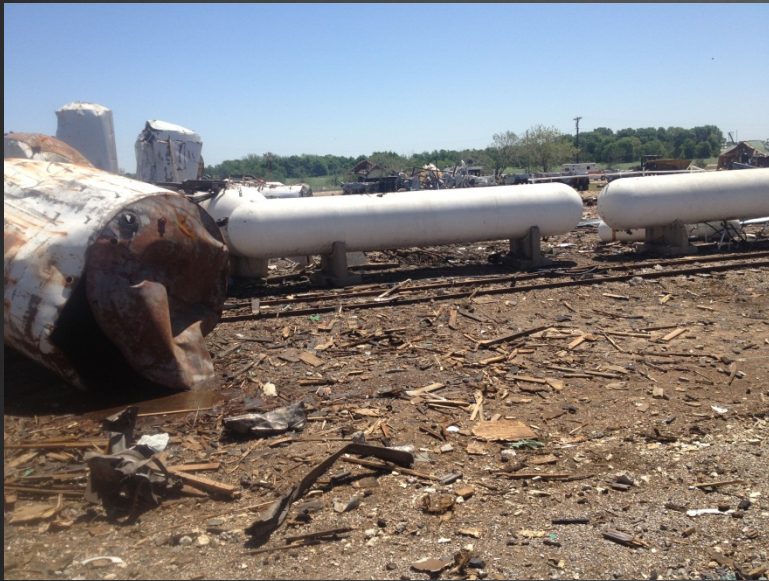
Anhydrous ammonia bullet tanks.

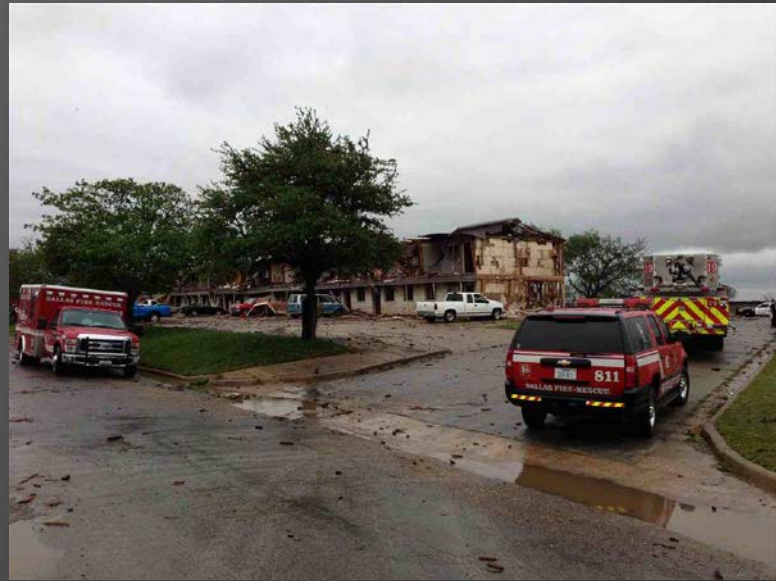
Damage to apartment complex.

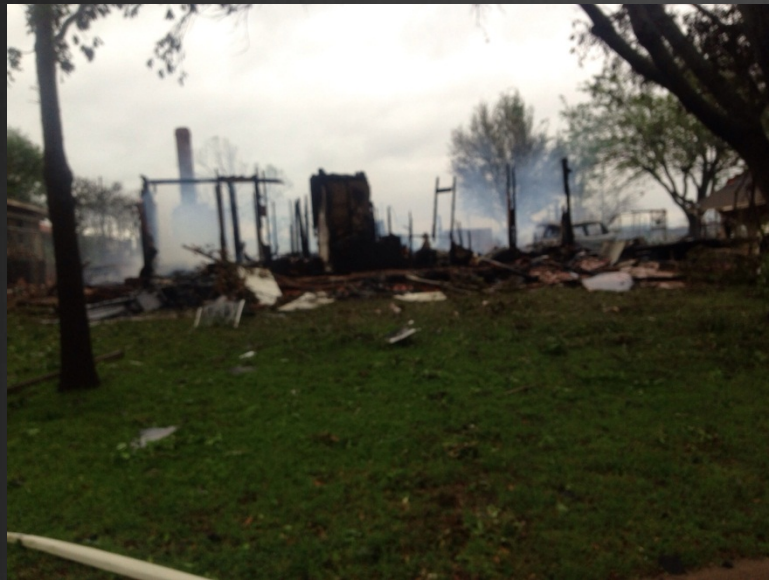
Damage to homes within the surrounding neighborhood.
